Jackson Hole, Wyoming Environmental Restoration Draft Feasibility Study

Draft Feasibility Study
and
Appendixes A - B

April 2000

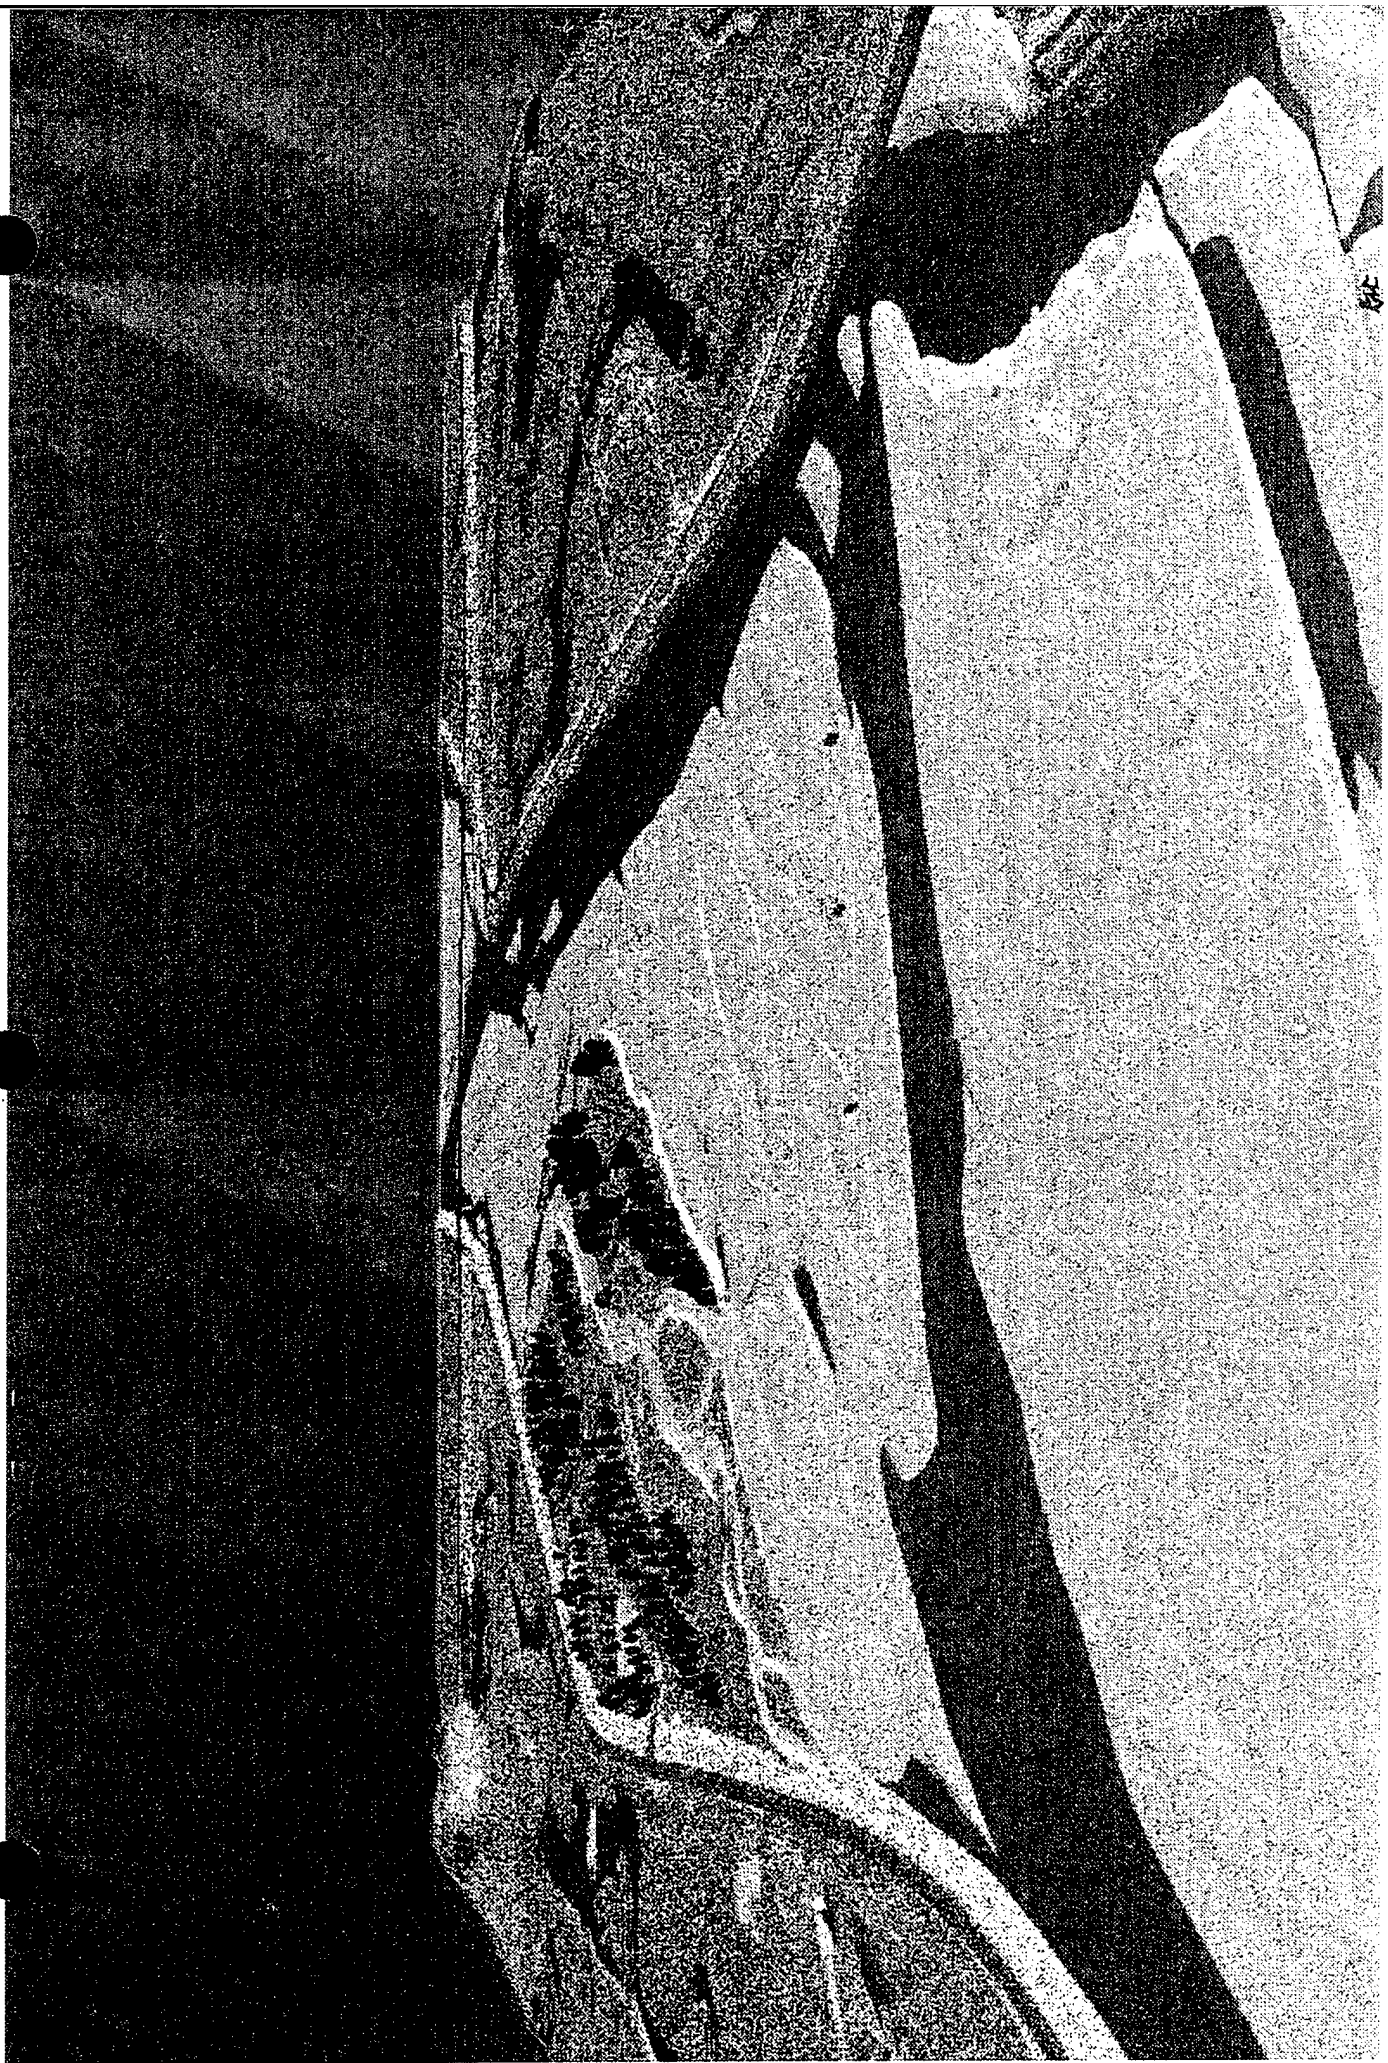
SITE 9 EXISTING (1996): VIEW LOOKING DOWNSTREAM

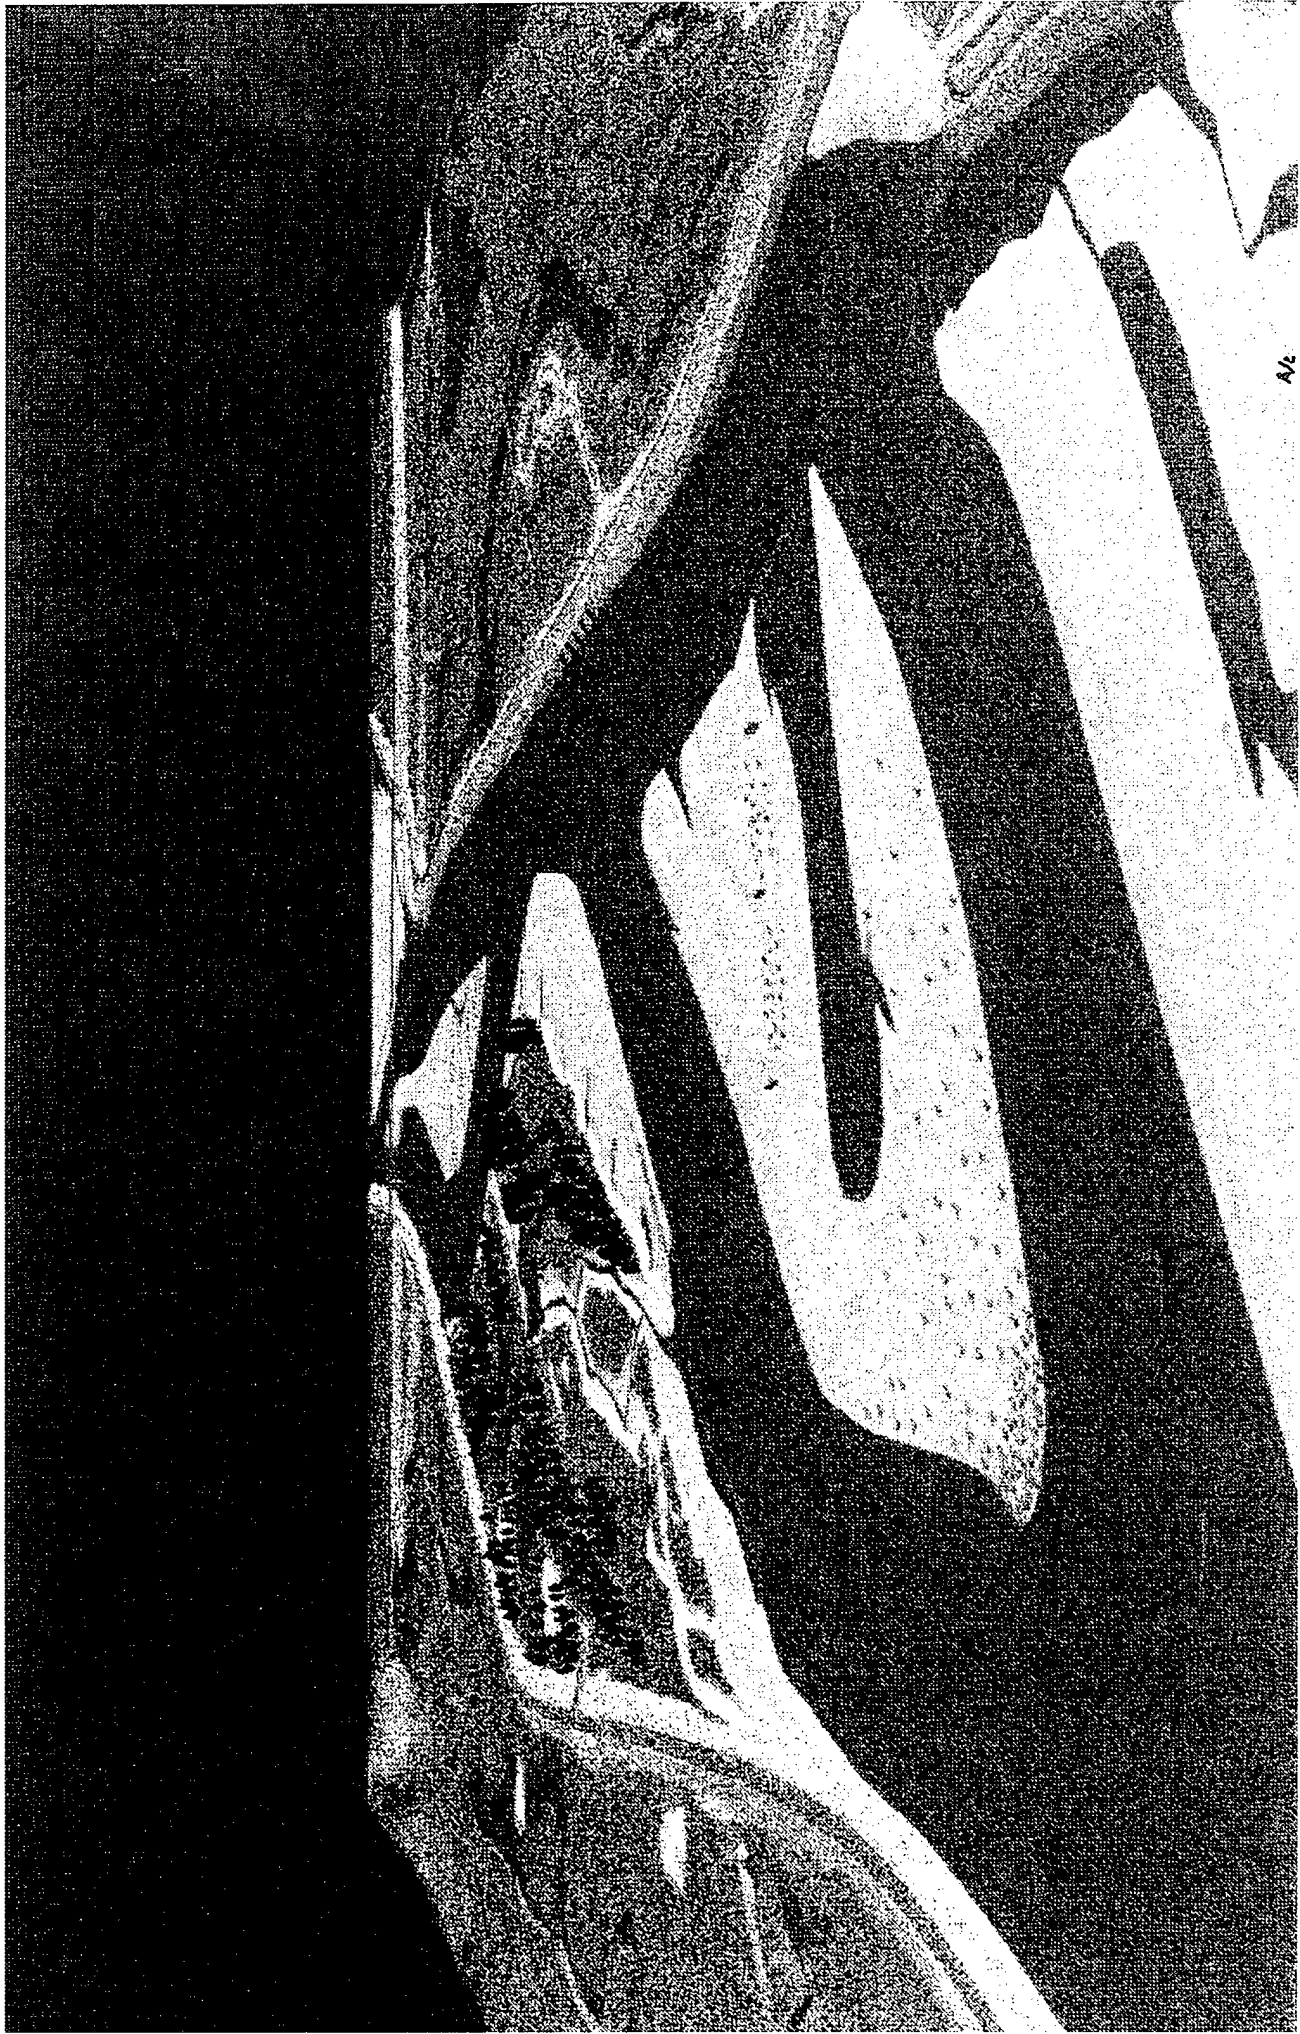
SITE 9 WITH-PROJECT 0-YEAR: VIEW LOOKING DOWNSTREAM

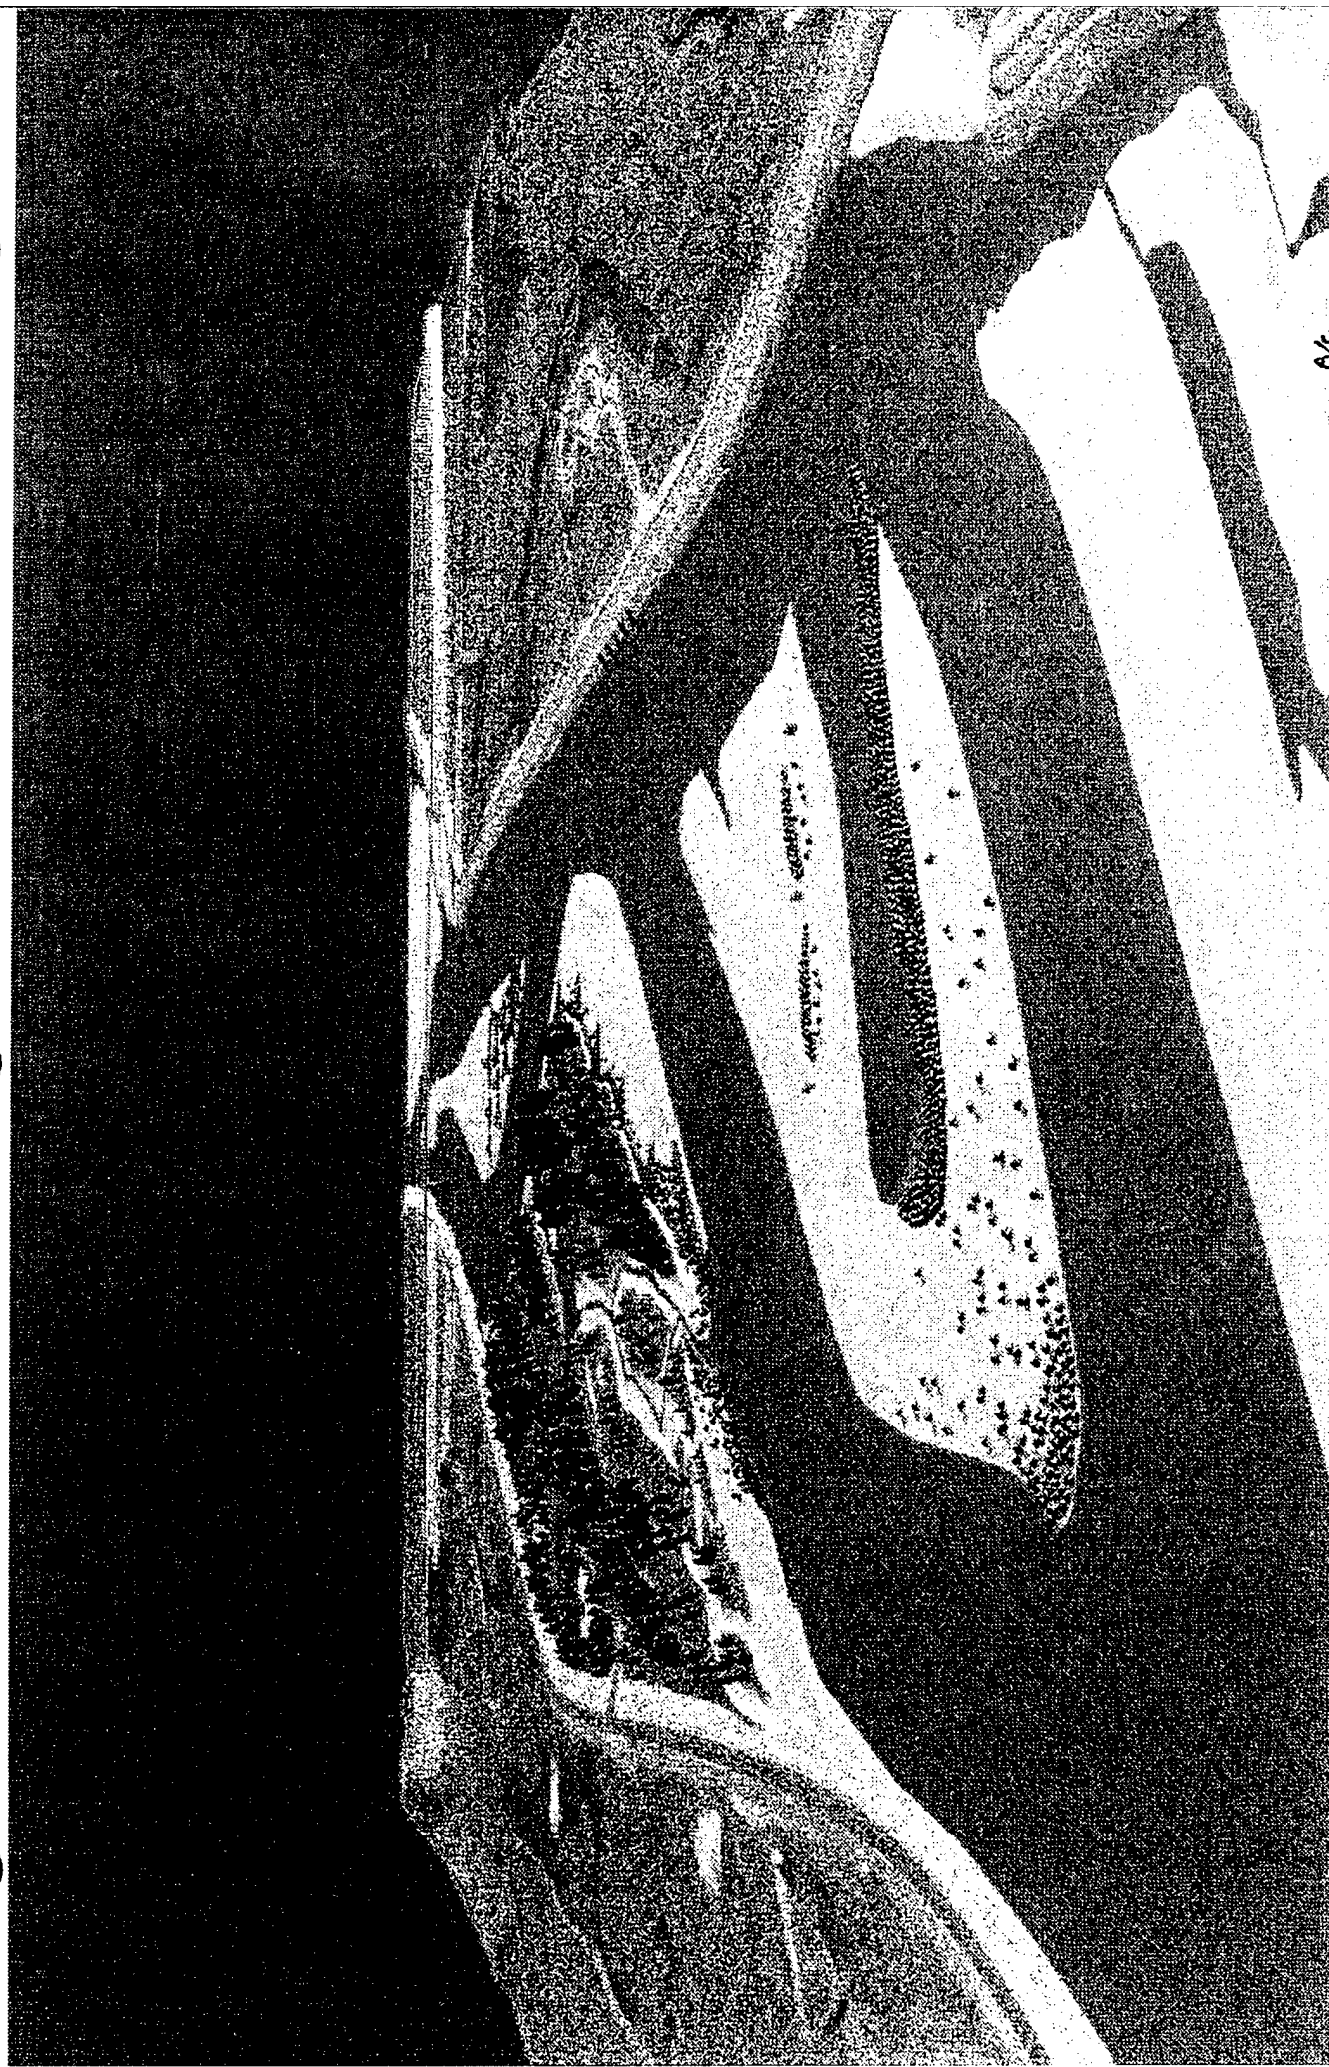
SITE 9 WITH-PROJECT 5-15 YEAR VEGETATION: VIEW LOOKING DOWNSTREAM

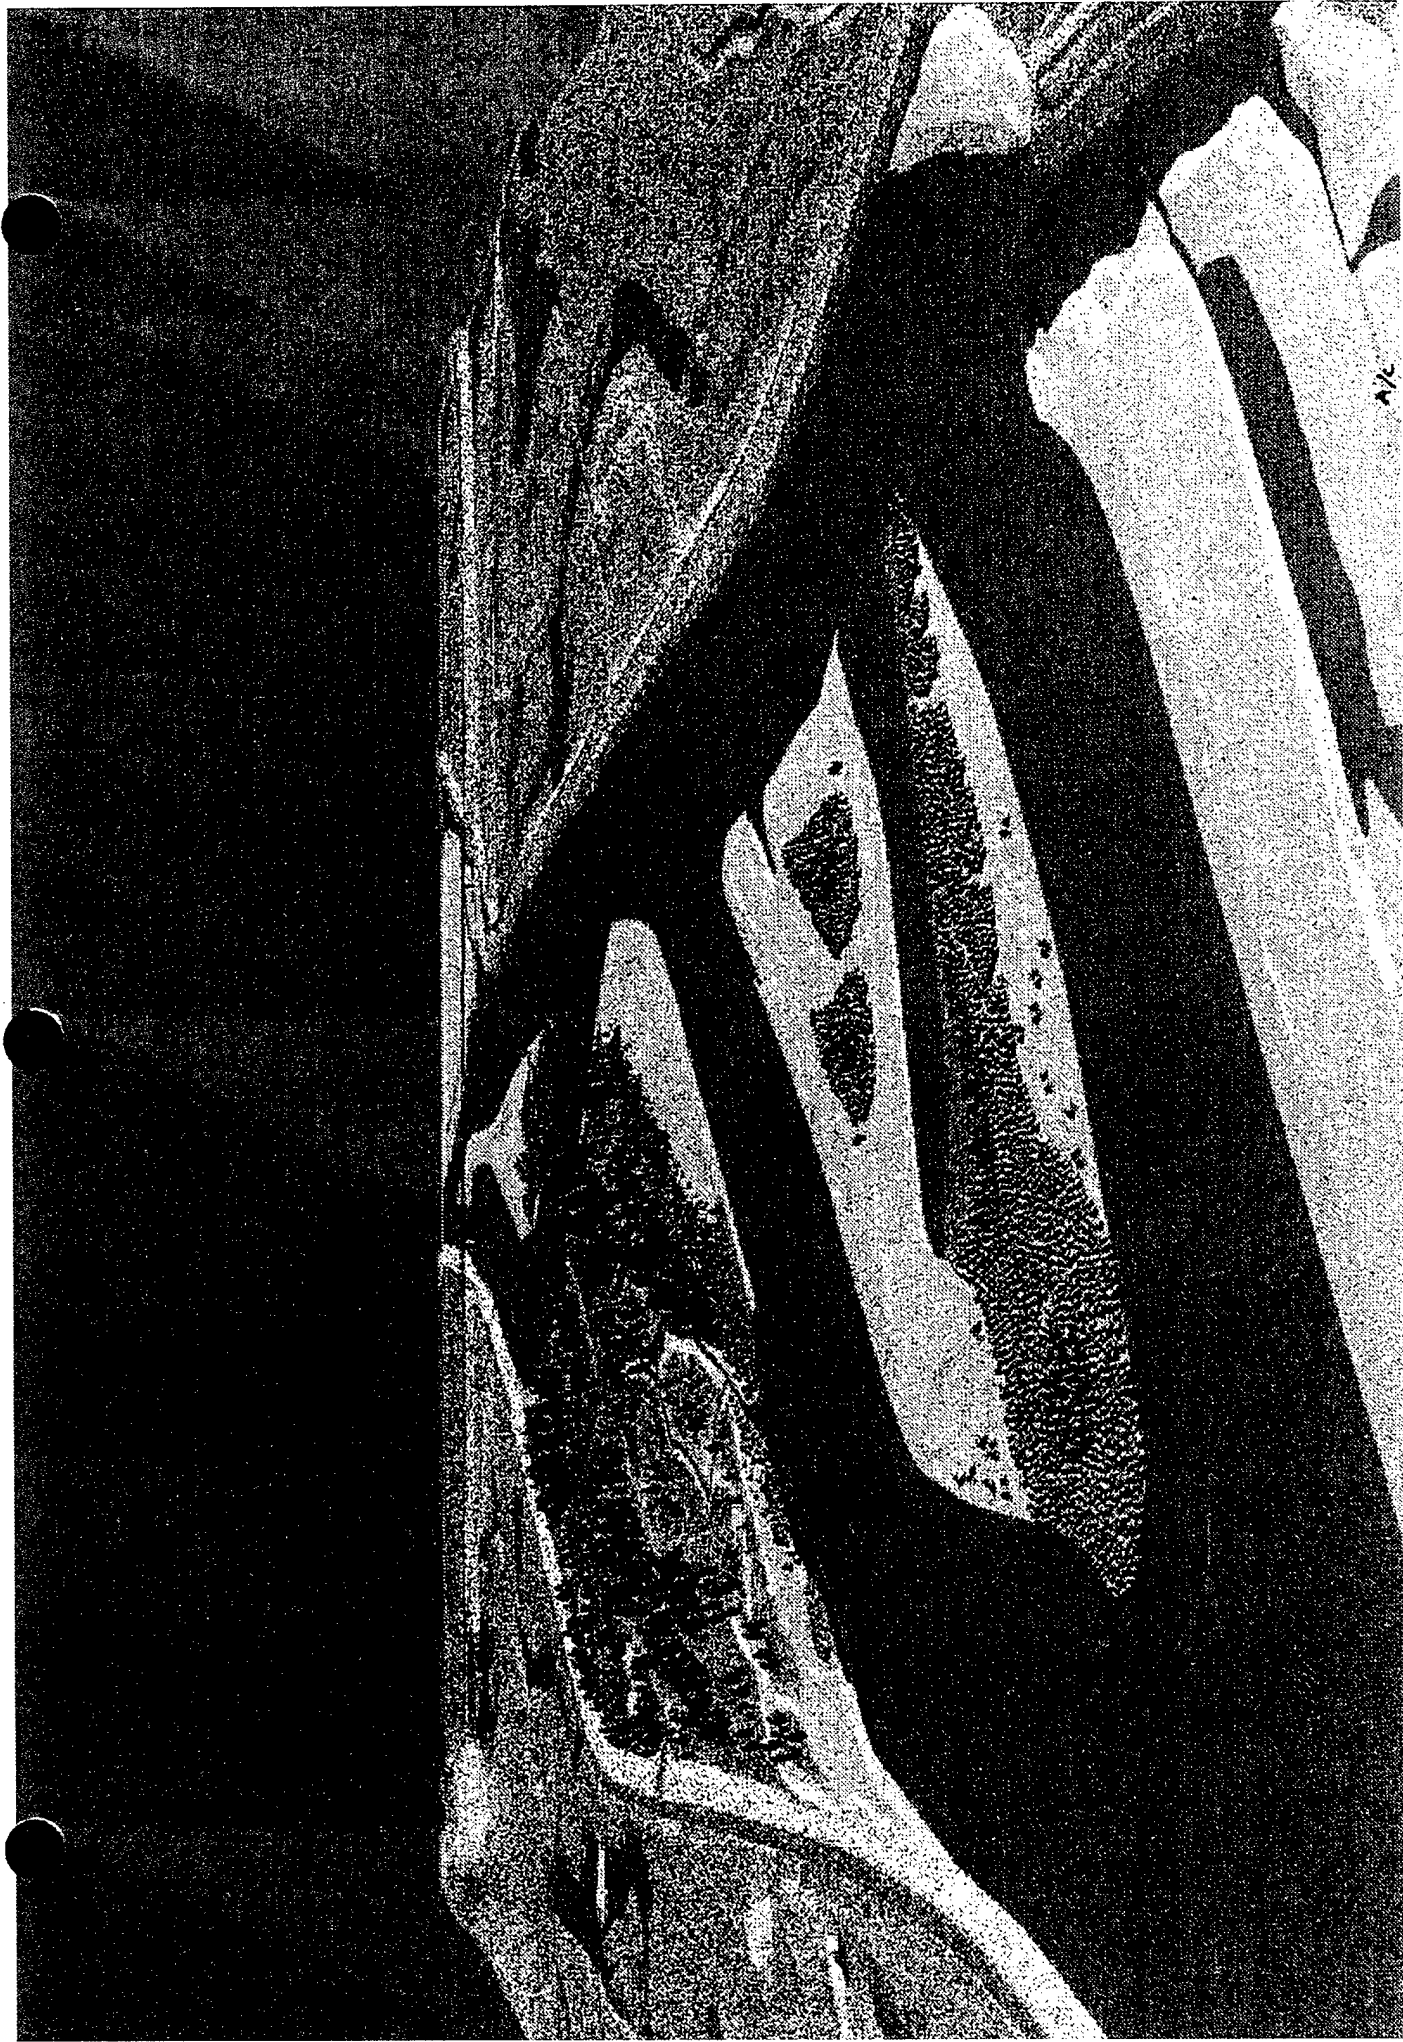
SITE 9 WITH-PROJECT 25-YEAR VEGETATION: VIEW LOOKING DOWNSTREAM

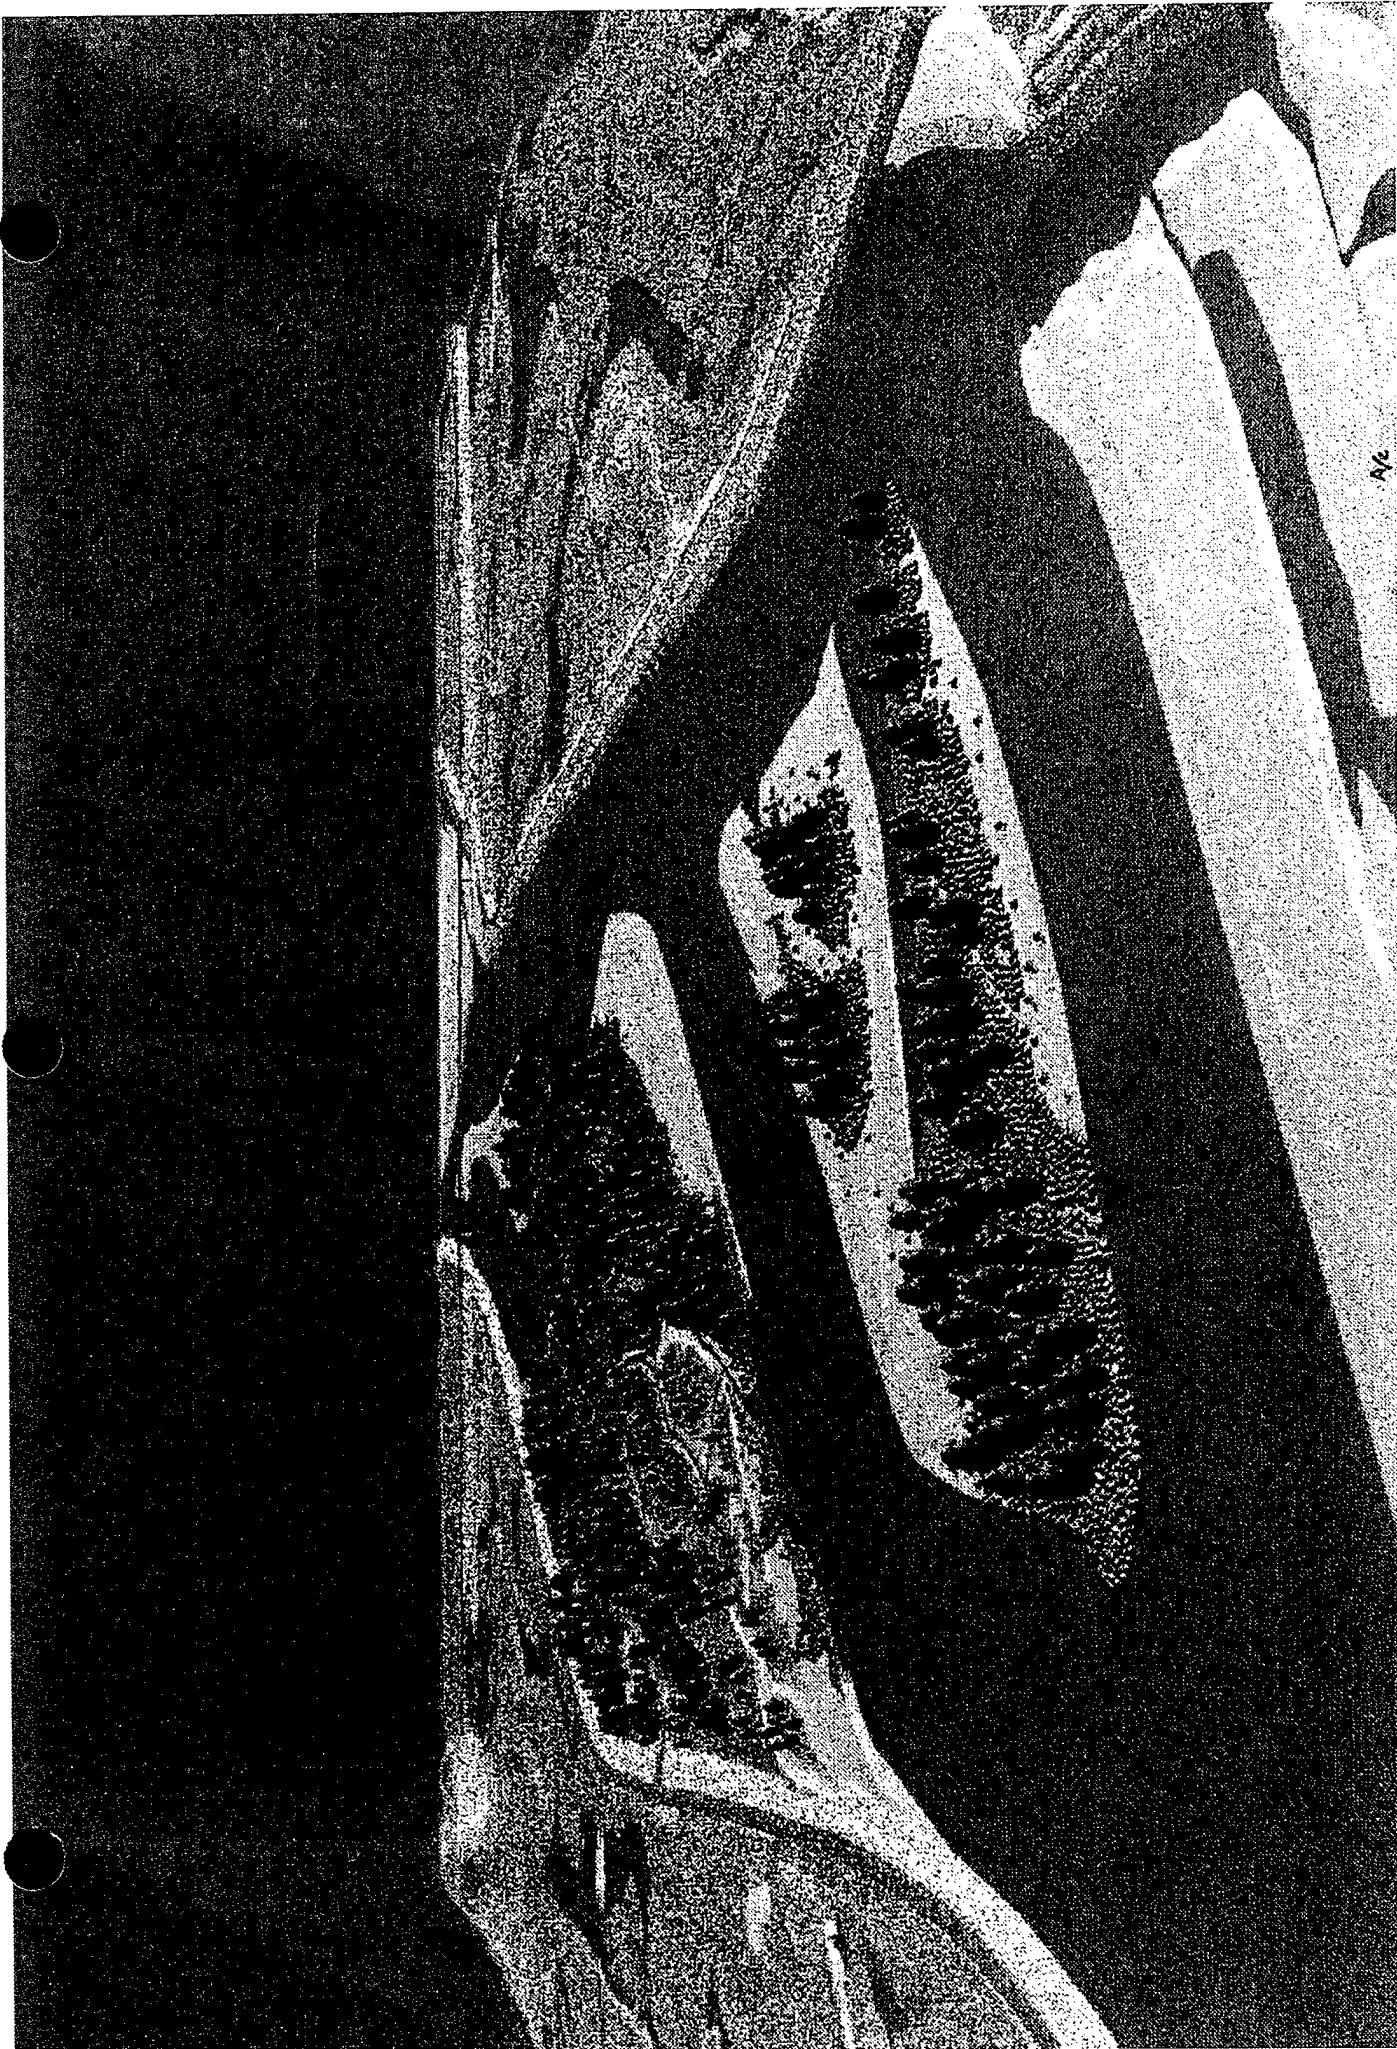
SITE 9 WITH-PROJECT 50-YEAR VEGETATION: VIEW LOOKING DOWNSTREAM

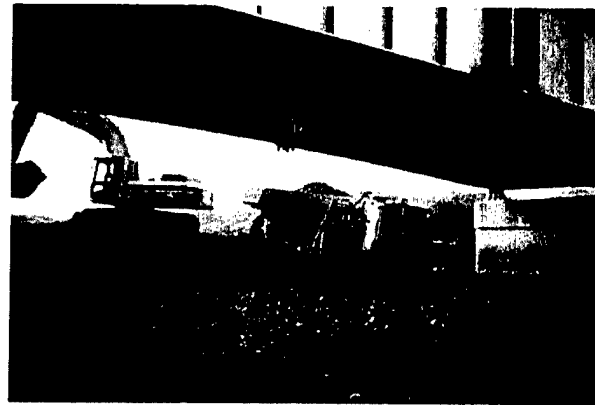
Channel management activity required additional heavy equipment in the immediate area of the Wilson Bridge. Aggradation of material was so excessive that the riverbed was lowered up to thirteen feet in this area. A small bulldozer was used to push the material out to the backhoe so that it could be loaded into the dump trucks

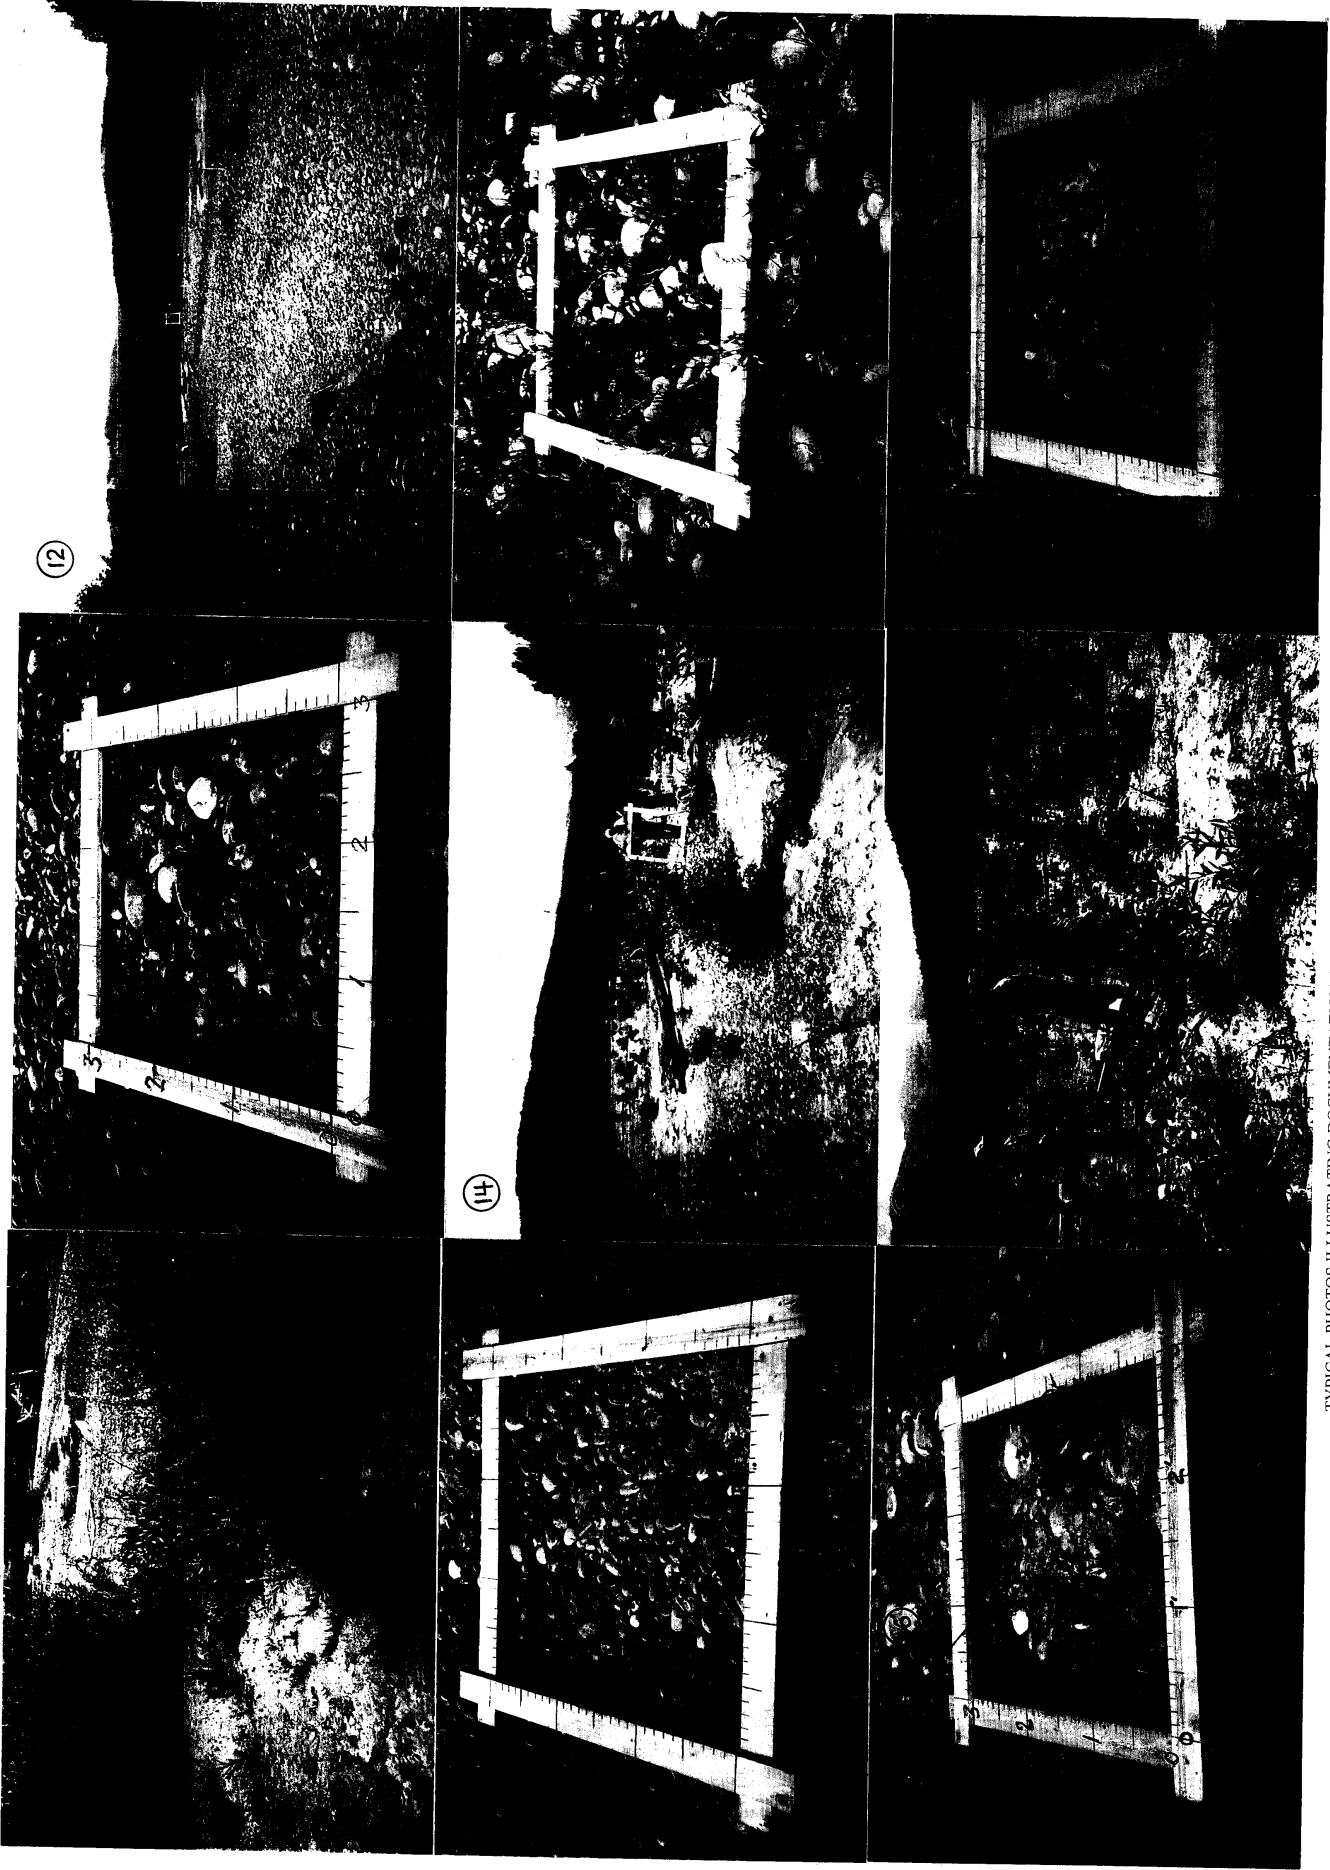
TYPICAL PHOTOS ILLUSTRATING DOCUMENTATION OF SEDIMENT SIZES

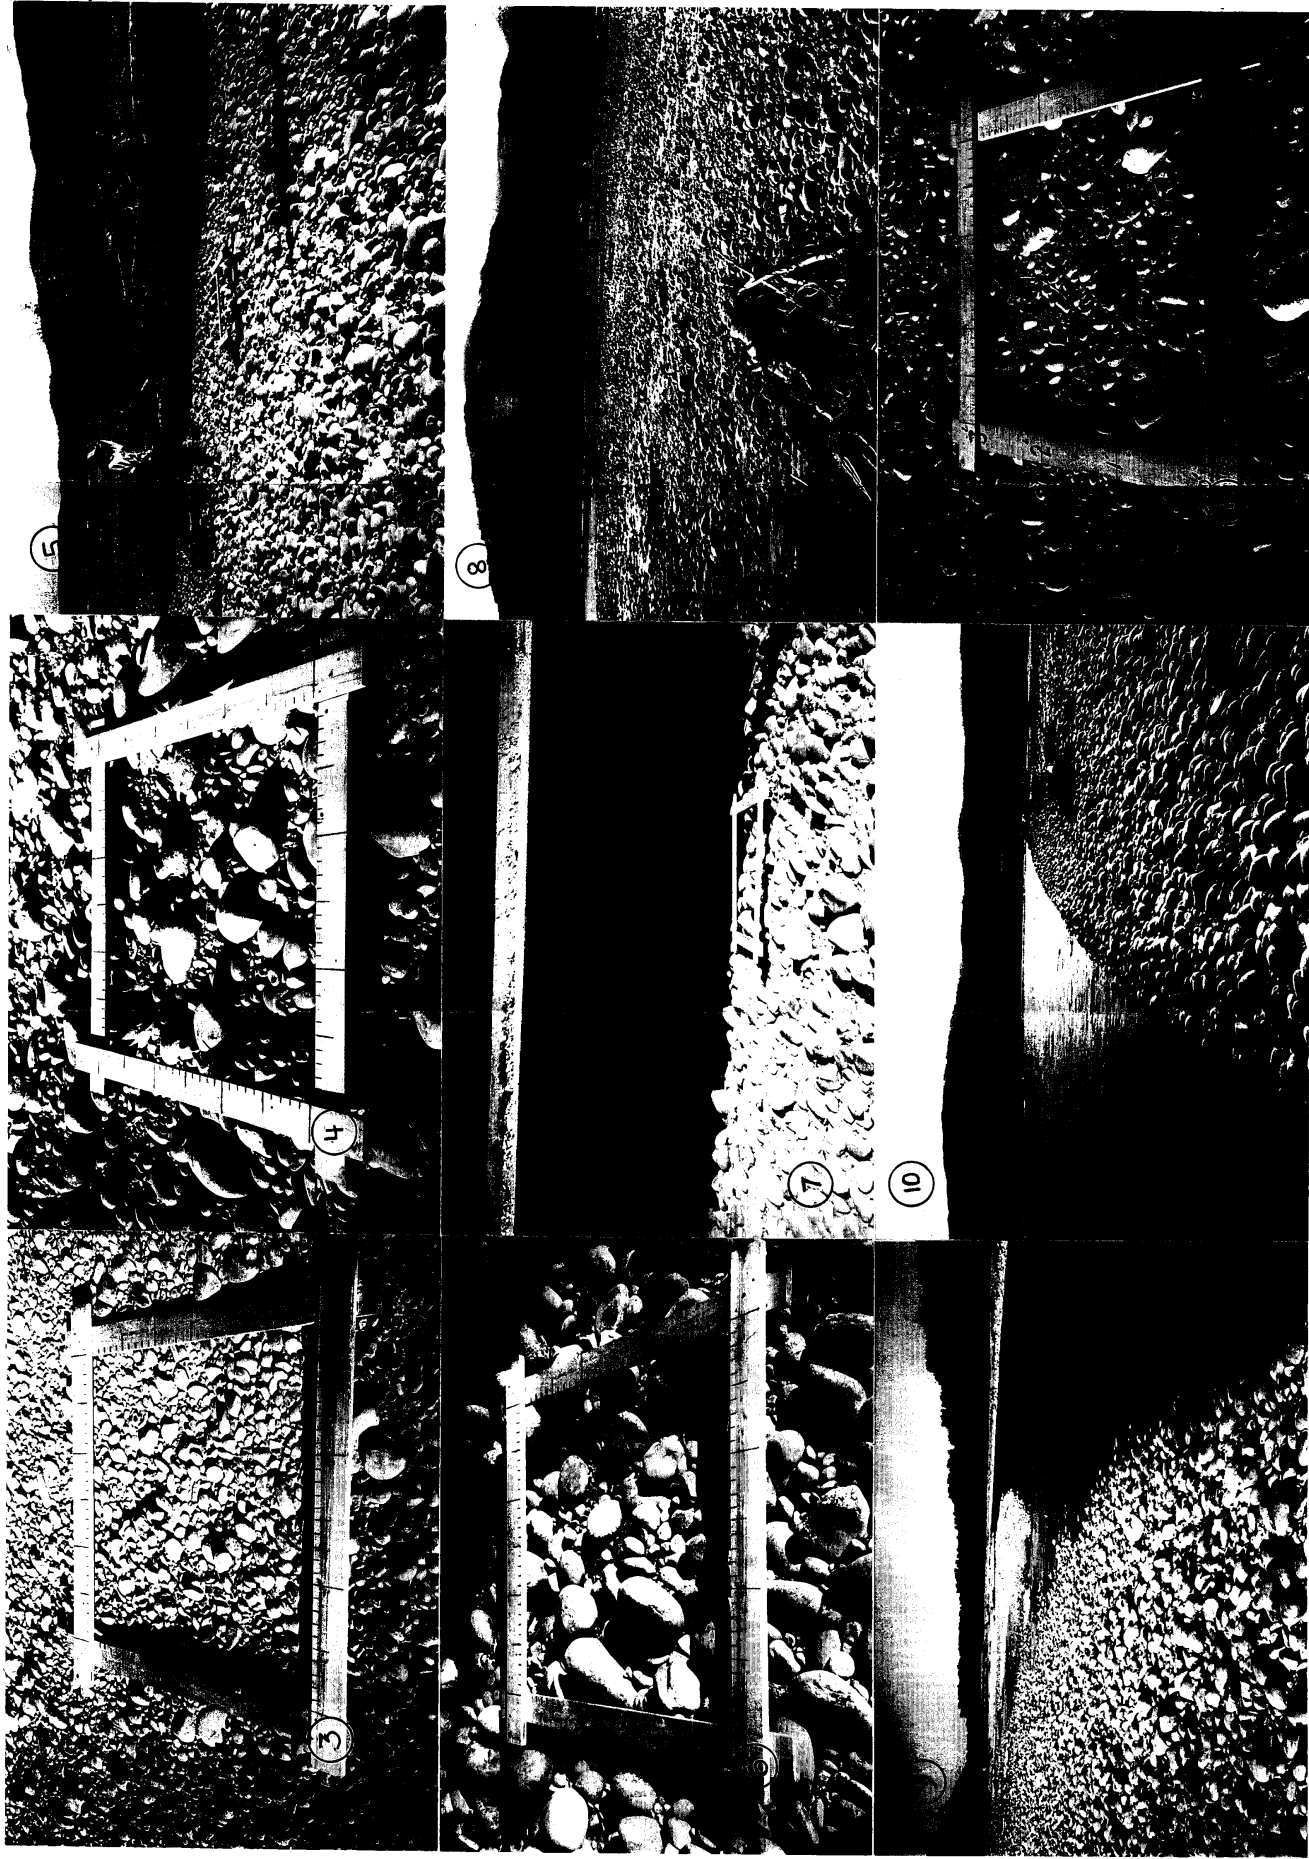
TYPICAL PHOTOS ILLUSTRATING DOCUMENTATION OF SEDIMENT SIZES

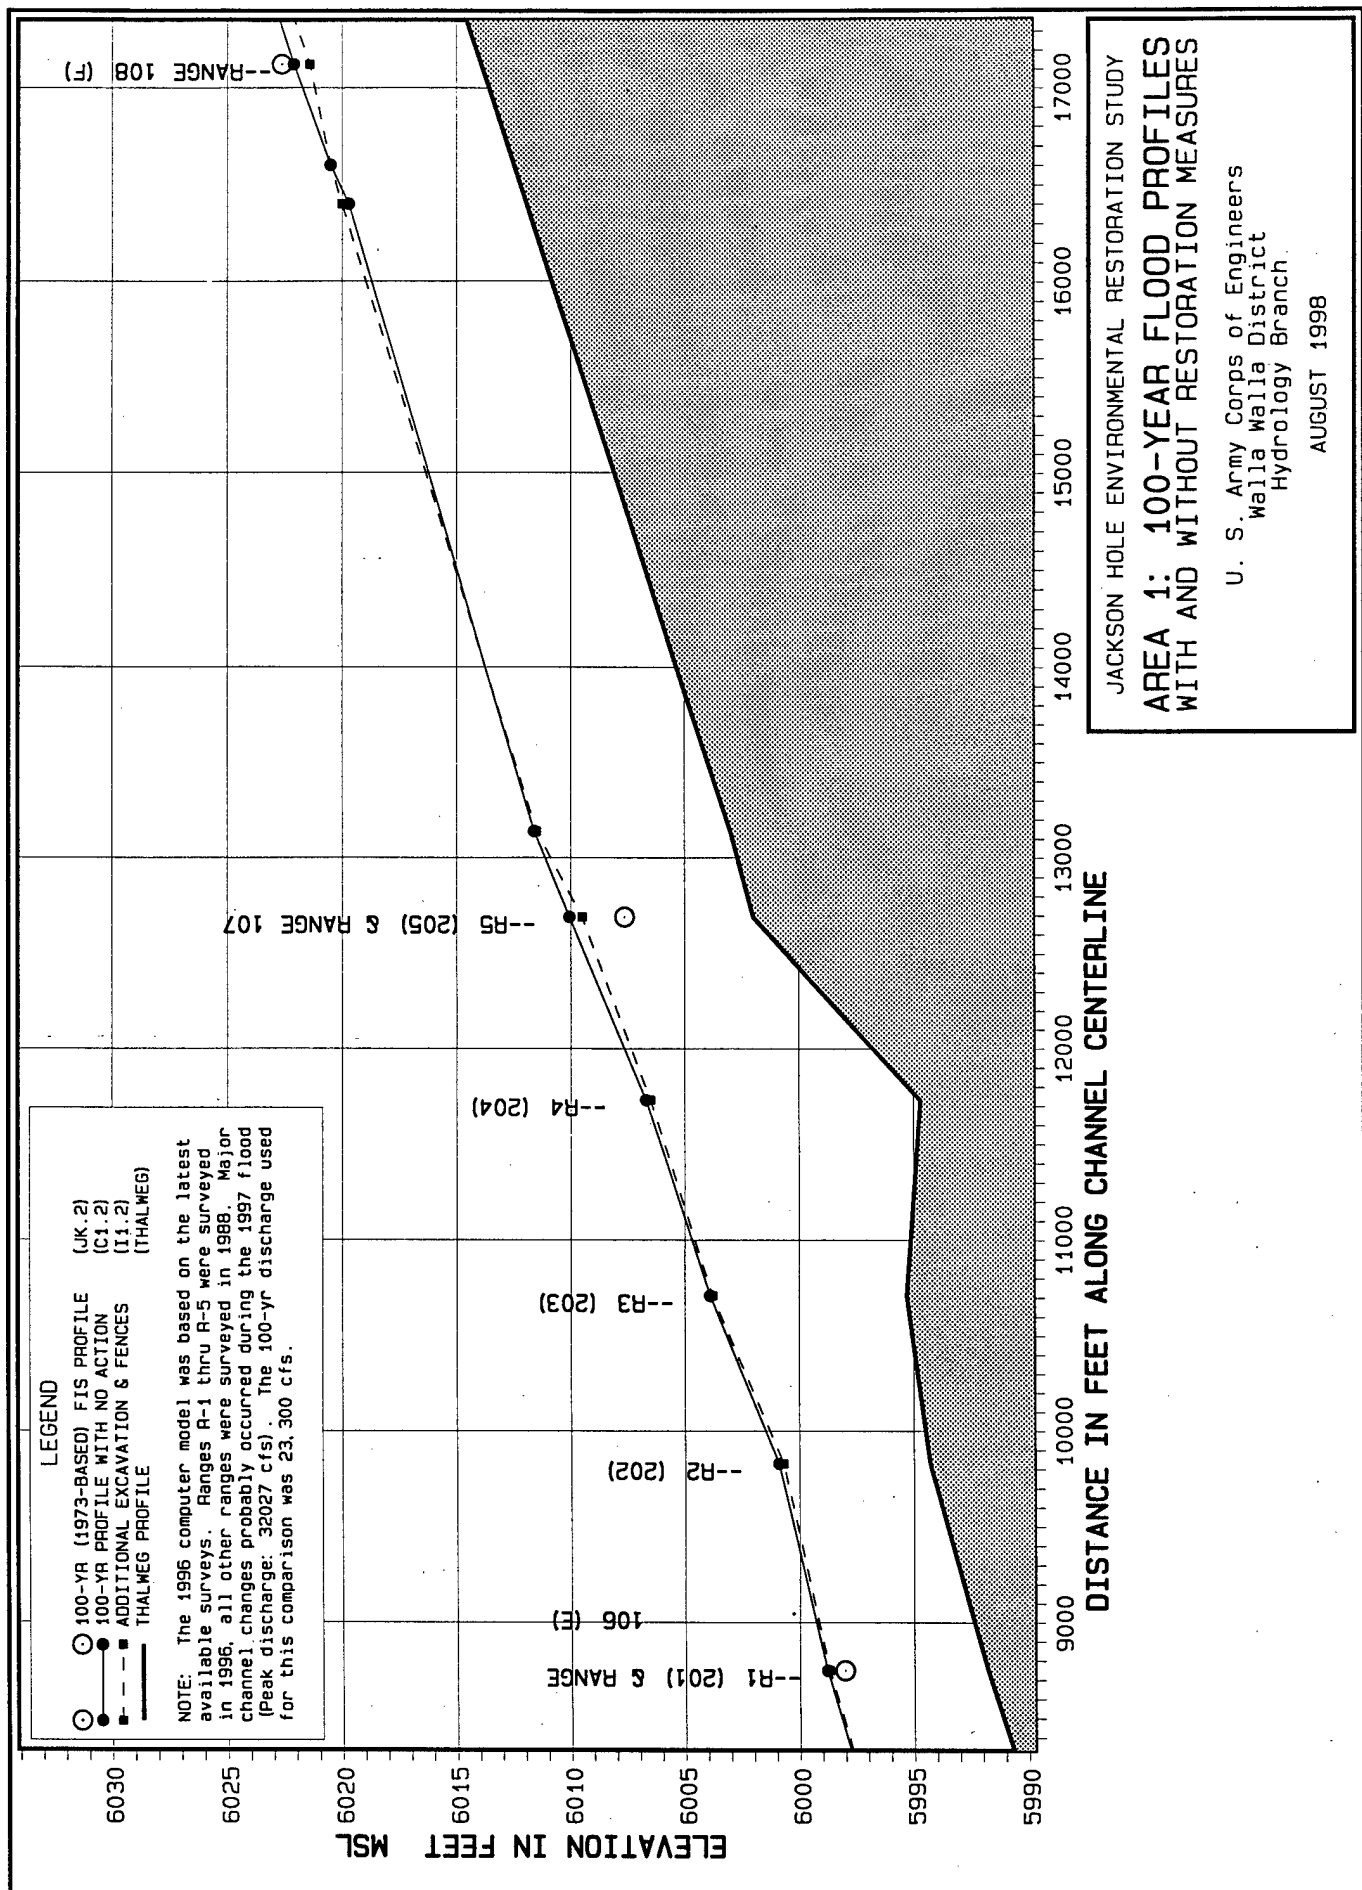
JACKSON HOLE ENVIRONMENTAL RESTORATION STUDY
**AREA 1: 100-YEAR FLOOD PROFILES
 WITH AND WITHOUT RESTORATION MEASURES**
